PERMIT DRAWINGS

WHETSTONE
 ENGINEERING & TESTING

PROJECT NAME: FARKAS RESIDENCE
 749 INDIAN BEACH, CIR
 SARASOTA, FLORIDA

PROJECT NUMBER: 412

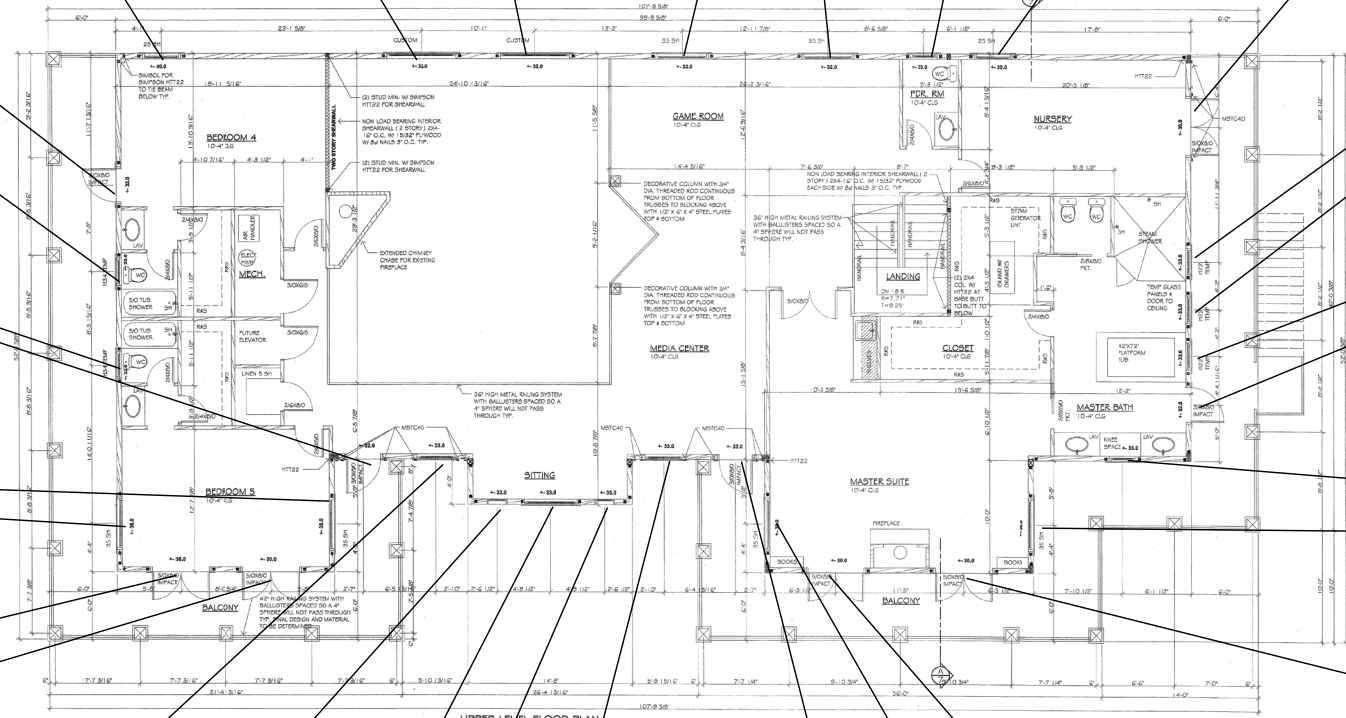
FOREST: 10/20/05
 NEEDS TO BE REMOVED AND REINSTALLED
 WILL NOT CLOSE, NEEDS TO BE TAKEN OUT
 AND REINSTALLED

FOREST: 12/07/05
 WILL NOT CLOSE, LOCK SILL DAMAGED
 TOUCH UP ON OUTSIDE OF DOOR

FOREST: 12/23/05
 THUMBTURN LATCH DOES NOT OPERATE -
 THROWS NOT ENGAGING STRIKES PROPERLY
 DOOR WILL NOT CLOSE PROPERLY
 NEED TOUCH UP ON INSIDE OF DOOR NEW
 SILL WILL BE ORDERED
 THIS UNIT WILL BE UNINSTALLED AND
 REINSTALLED

BRACKEN ENGINEERING: 03/23/07
 EXHIBITED A REVERSE PITCHED SILL PAN
 SERVING TO PROMOTE WATER INTRUSION
 TWO NAILS HAD BEEN EMBEDDED THROUGH
 THE PEEL-AND-STICK IMMEDIATELY ABOVE
 THE VERTICAL LEG
 THE LEFT CORNER OF THE DOOR
 ASSEMBLY COINCIDENT WITH THE SILL PAN
 EVIDENCED A SIGNIFICANT GAP WHERE WATER
 FLOW ATOP THE PAN WOULD ENTER THE
 STRUCTURE

TESTED: FAILED
 BRACKEN ENGINEERING: 03/23/07

FOREST: 10/20/05
 NEEDS ADJUSTMENTS
 FOREST: 12/07/05
 BOTTOM SASH GLAZING BEAD
 FOREST: 12/23/05
 OUTSIDE GLAZING BEAD ON
 BOTTOM SASH NEEDS TO BE
 REPLACED

FOREST: 10/20/05
 NEEDS TO BE REMOVED
 AND REINSTALLED
 WILL NOT CLOSE, MISSING
 SCREWW COVERS AND
 STRIKE PLATE AT TOP

FOREST: 10/20/05
 NEEDS TO BE REMOVED AND REINSTALLED
 DO NOT OPERATE WELL, NEED NEW SILLS
 FOREST: 12/23/05
 FIX DRYWALL OR CAULK CORNER SO THAT
 RETURN TO UNIT IS CLEAN

FOREST: 10/20/05
 NEEDS TO BE REMOVED AND REINSTALLED
 DO NOT OPERATE WELL, NEED NEW SILLS
 FOREST: 12/07/05
 TOUCH UP FOR DAMAGE ON INSIDE TOP
 METAL BENT ON OUTSIDE THUMB TURN
 DOES NOT LOCK

FOREST: 12/23/05
 TOUCH UP DAMAGE ON INSIDE LEFT RAIL
 AS YOU ARE LOOKING FROM INSIDE
 THUMB LATCH DOES NOT OPERATE THROWS
 NOT ENGAGING IN STRIKES PROPERLY
 TOP METAL DRIP EDGE BENT, NEEDS TO
 BE STRAIGHTENED
 FIX DRYWALL OR CAULK CORNER SO
 THAT RETURN TO UNIT IS CLEAN

FOREST: 10/20/05
 NEEDS ADJUSTMENTS
 FOREST: 12/07/05
 TOUCH UP ON DOOR INSIDE FACE, THUMB
 TURN CAULKING, CORNER NEEDS TO BE
 CAULKED
 FOREST: 12/23/05
 THUMBTURN LATCH DOES NOT OPERATE -
 THROWS NOT ENGAGING IN STRIKES
 PROPERLY
 FIX DRYWALL OR CAULK CORNER SO THAT
 RETURN TO UNIT IS CLEAN
 NEED TOUCH UP ON INSIDE OF DOOR

FOREST: 10/20/05
 NEEDS ADJUSTMENTS
 BRACKEN ENGINEERING: 03/23/07
 INSPECTION OF THE WALL CAVITY
 REVEALED WATER DRIPPING FROM THE
 2X4 SILL TO PLYWOOD SHEATHING
 INTERFACE. (WATER TESTING WAS
 DONE JUST PRIOR)
 SEPERATIONS AT THE MASONRY
 OPENING TO WINDOW EXTERIOR CASING

TESTED: FAILED
 BRACKEN ENGINEERING: 03/23/07
 BRACKEN ENGINEERING: 02/18/08

FOREST: 10/20/05
 NEEDS TO BE REMOVED AND REINSTALLED
 DRAGGING, LOCK JAMB BOWED, NEEDS NEW SILL
 FOREST: 12/07/05
 DOES NOT CLOSE PROPERLY / SCRATCHES NEED
 TOUCH UP
 FOREST: 12/23/05
 DOES NOT CLOSE PROPERLY
 SCRATCHS ON OUTSIDE OF DOOR NEED TOUCH
 UP

FOREST: 10/20/05
 NEEDS TO BE REMOVED AND REINSTALLED
 NEEDS NEW SILL, NOT OPERATING WELL
 FOREST: 12/23/05
 FIX DRYWALL OR CAULK CORNER SO THAT RETURN TO UNIT IS CLEAN
 IBA: 07/20/06
 UNCONTROLLED WATER INTRUSION WAS OBSERVED PERCOLATING OVER
 SILL OF SPECIMAN.
 UNCONTROLLED WATER INTRUSION WAS OBSERVED EXITING GLAZING
 INFILL CORNERS OF BOTH DOOR PANELS AT THE RIGHT CORNER
 LOCATION
 UNCONTROLLED WATER INTRUSION WAS OBSERVED EXITING THE METAL
 TO METAL FRAME JOINT AT THE TOP LEFT CORNER OF THE RIGHT
 PANEL
 UNCONTROLLED WATER INTRUSION WAS OBSERVED EXITING BETWEEN
 THE HEAD OF THE SPECIMEN, BETWEEN THE DOOR PANEL STILES AT
 THE ASTRICAL STILE
 THUMBTURN LATCH DOES NOT OPERATE - THROWS
 NOT ENGAGING IN STRIKES PROPERLY

FOREST: 10/20/05
 NEEDS TO BE REMOVED AND REINSTALLED
 NEEDS NEW SILL, NOT OPERATING WELL
 FOREST: 12/07/05
 STRIKE PLATES NEED ADJUSTMENTS SO TURNS GO IN
 FOREST: 12/23/05
 FIX DRYWALL OR CAULK CORNER SO THAT RETURN TO
 UNIT IS CLEAN
 THUMBTURN LATCH DOES NOT OPERATE - THROWS
 NOT ENGAGING IN STRIKES PROPERLY

TESTED: FAILED
 IBA CONSULTANTS: 07/20/06
 BRACKEN ENGINEERING: 03/23/07
